Monitoring Completed Navigation Projects Program

Periodic Inspections of Cleveland Harbor East Breakwater, Ohio, and Burns Harbor North Breakwater, Indiana

May 2015

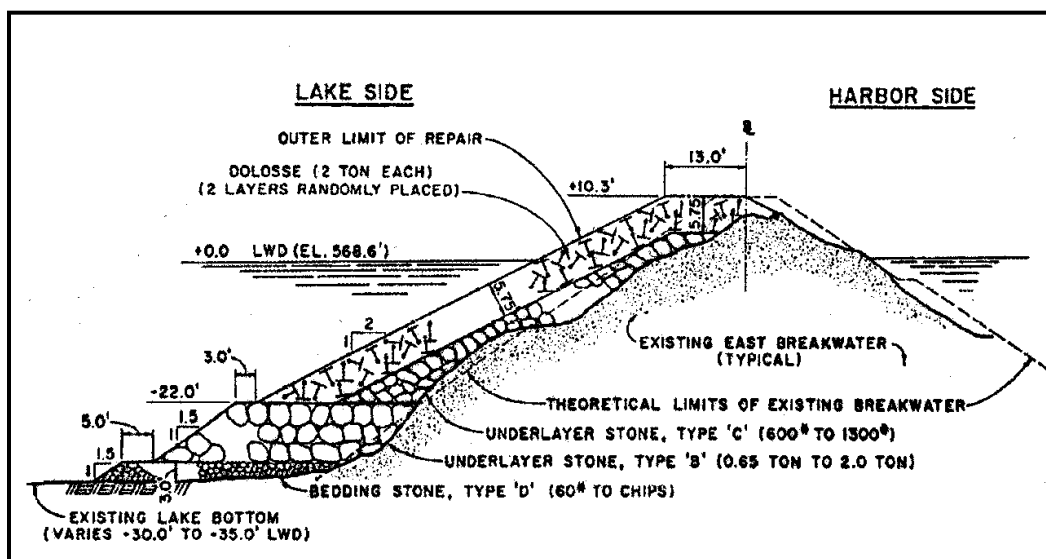
Figure 5. Cross section of major dolosse rehabilitation area of eastern 4,400 ft section of Cleveland Harbor East Breakwater following 1980 rehabilitation.

The East Breakwater has had an extensive repair and rehabilitation history. Storm damage caused armor stone displacement and subsequent unraveling of the breakwater slope in many areas. Frequent repairs were made using original construction methods until a major rehabilitation in 1979–1980. This construction involved the placement of 2-ton dolosse on the lakeward slope and damaged crest of the easterly 4,400 ft of the East Breakwater. Dolosse were placed at a 1V:2H slope on the breakwater trunk and a 1V:2.5H slope on the breakwater head to provide armoring (Figure 5).

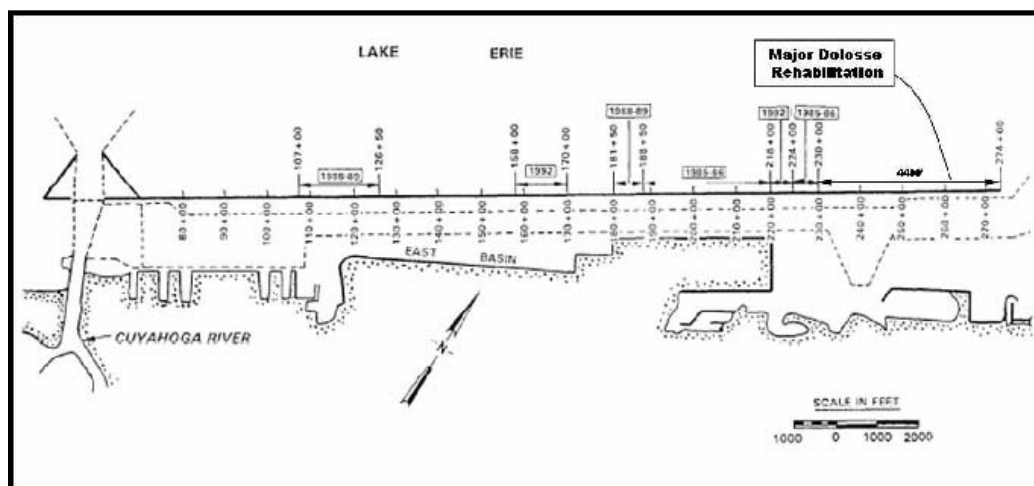
Figure 7. Cleveland Harbor East Breakwater layout with stone (1985–1992) and dolos (1986) rehabilitation areas.

(Markle and Dubose 1985). An aerial photograph of the breakwater head (Figure 6) shows the size difference in the 2-ton and 4-ton dolosse. Other recent repairs to the East Breakwater took place in 1986, 1989, 1991, and 2001 on various sections of the westerly 16,570 ft. No dolosse were used in these areas. The harbor layout and repair/rehabilitation areas can be seen in Figure 7.

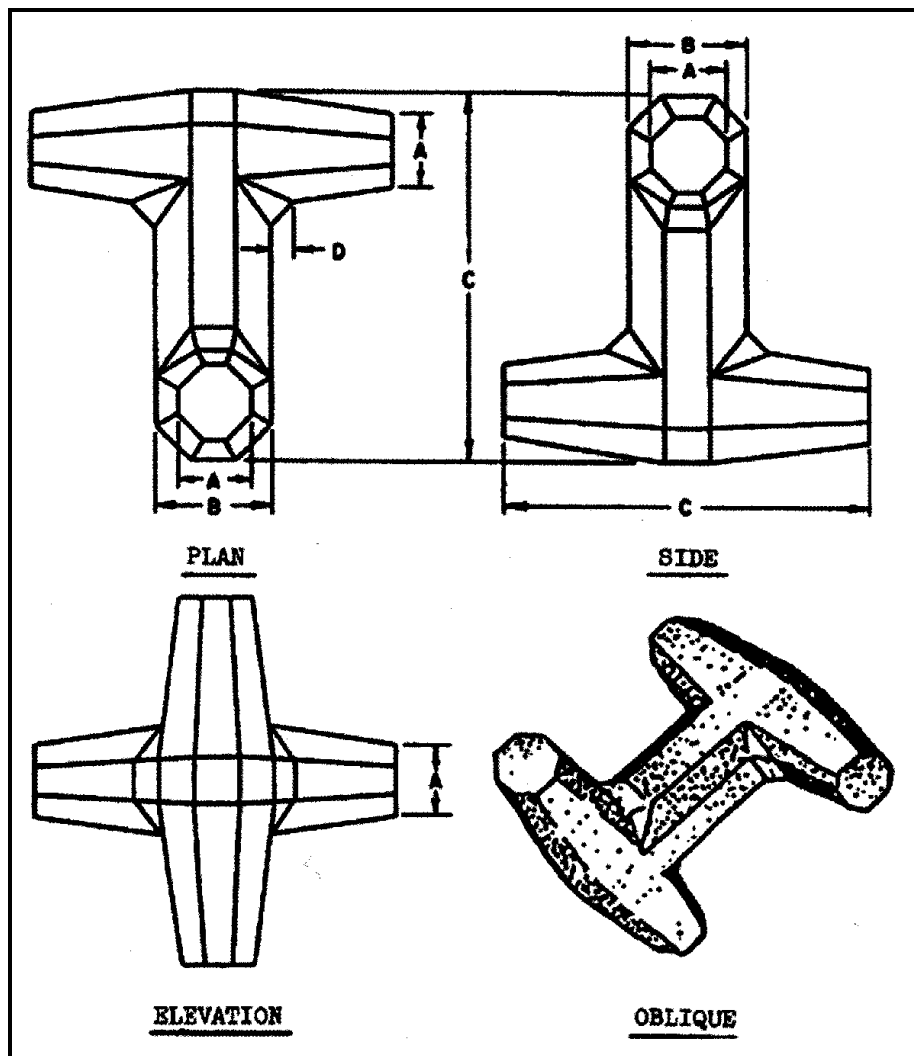
Figure 13. Various views of a dolos armor unit.

slender central sections and long legs produce very high stresses in the central sections of the units. This results in units that break into pieces having much less mass than the original unit. The broken units have little stability and may contribute to the breaking of adjacent units (Turk and Melby 1995).

The center section of the dolosse is referred to as the shank while the legs are called flukes. Dolos breaks were characterized according to Melby and Turk (1994) and recorded as one of the following during the walking inspections: (a) mid-shank, (b) shank-fluke (shank broken near one of the flukes), or (c) fluke-shank (fluke broken near the shank). Additional recorded details beyond those given by Melby and Turk included whether the breaks were straight or angled. This would indicate flexure or torsional shear failure. Damage was further specified as cracks, broken fluke tips,

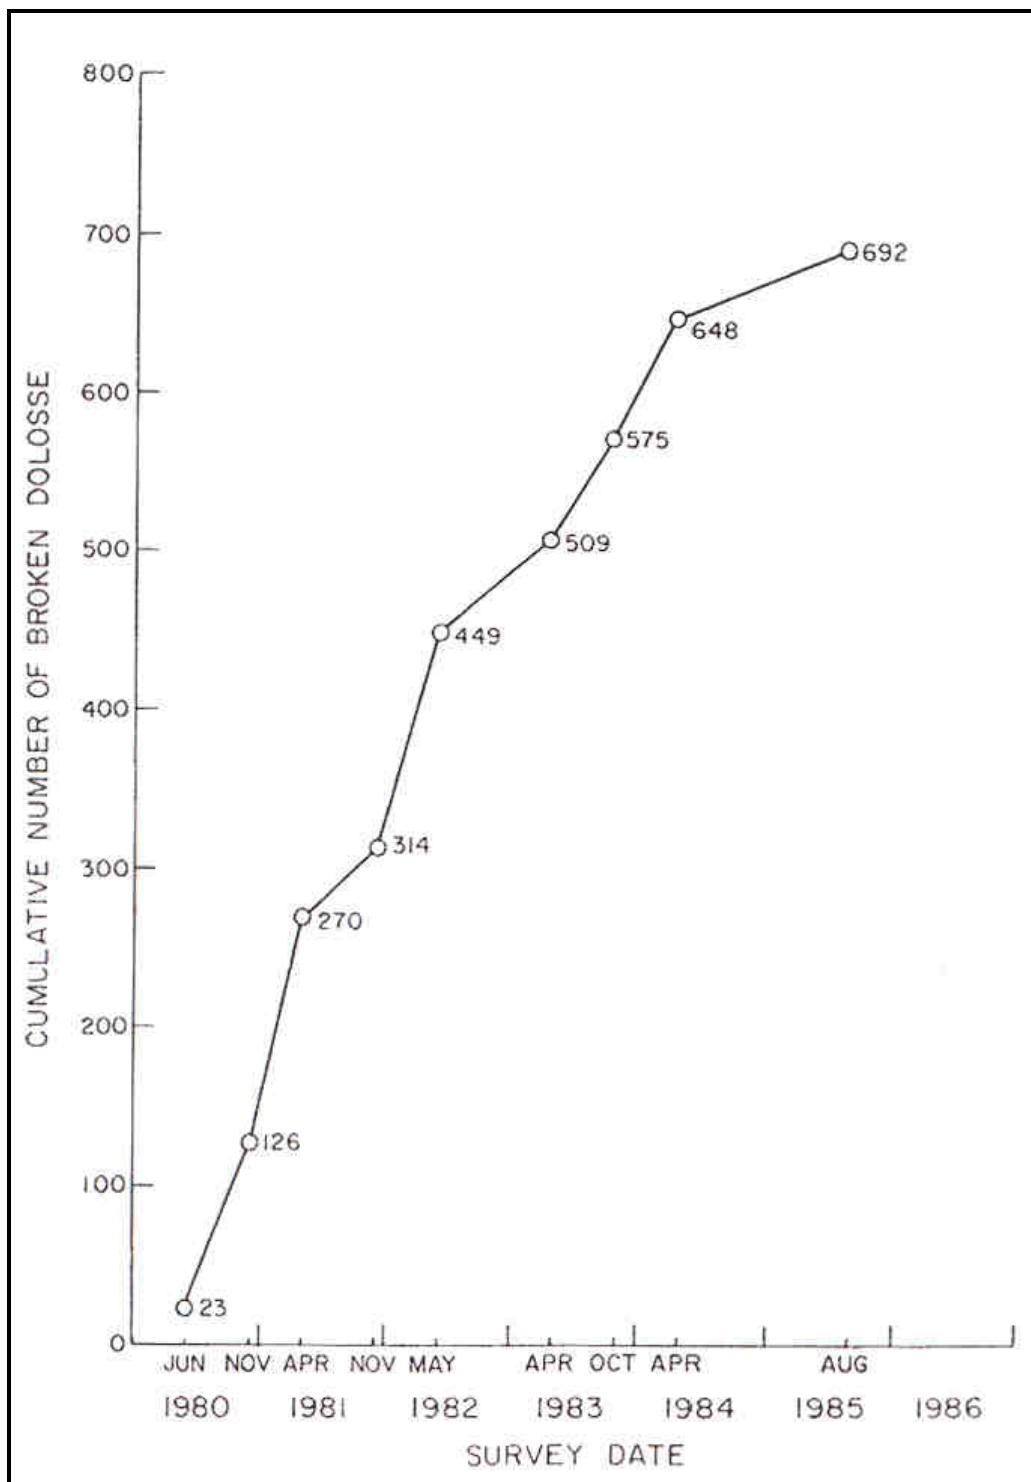
Figure 18. Cumulative number of broken dolos armor units located during 1980–1985 initial monitoring (comprehensive), Cleveland Harbor East Breakwater (after Pope et al. 1993).

Above-water broken dolos inventories were conducted 10 times during the monitoring period. Records indicates that 692 broken units were documented. Of this number, approximately 60% of the breakage occurred following the first year of construction and a period surrounding a storm in April 1992 (Figure 18). Angled breaks outnumbered straight breaks, and most breaks were classified as fluke breaks. Of the shank breaks, the number of angled and straight breaks was approximately the same.

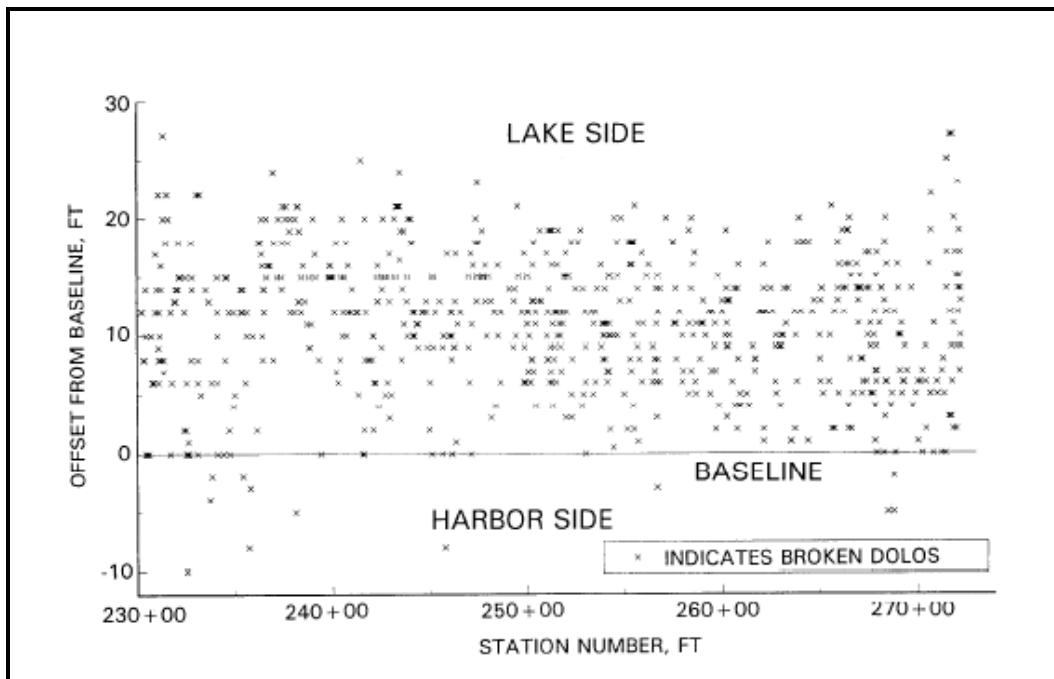
Figure 20. Distribution of broken dolos armor units along Cleveland Harbor East Breakwater relative to station number, June 1993 monitoring (after Bottin et al. 1995).

The June 1993 broken armor unit monitoring of the dolos section indicated 782 broken/cracked dolos above the water line. Forty-eight of these had multiple breaks. Only 7 of the 782 were 4-ton units. A distribution of damaged dolos relative to station number can be seen in Figure 20.

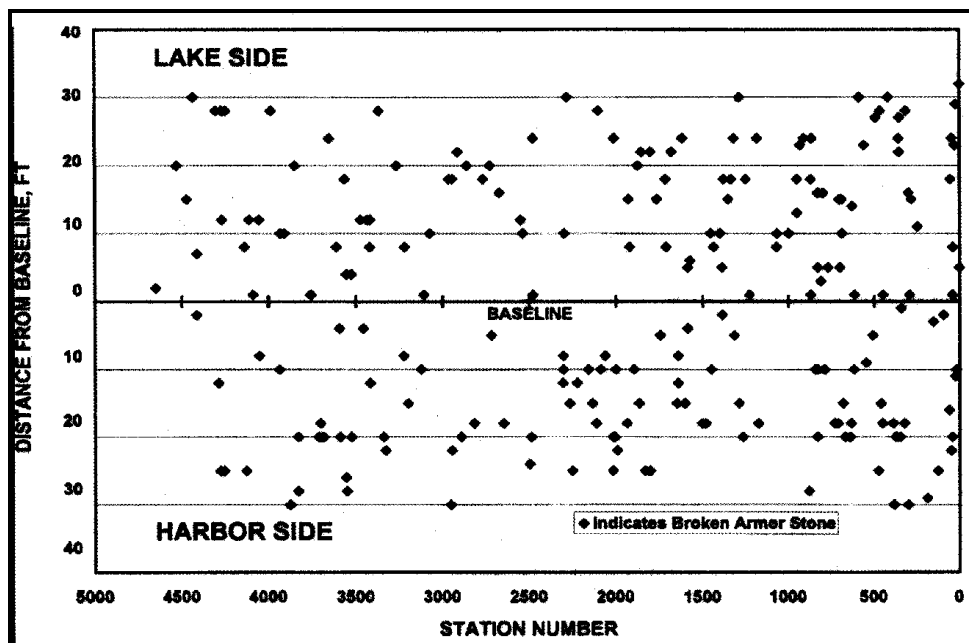
A total of 225 broken armor units were documented during the 1999 survey [Figure 23] versus 165 during the previous survey. Data indicated the majority of additional stone breakage occurred on the harbor side of the structure as opposed to the lakeside. As in the previous survey, higher concentrations of broken stone were noted on the eastern one-third of the breakwater during the current monitoring effort.

Figure 23. Distribution of broken armor stones on Burns Harbor North Breakwater, August 1999 walking inspection (after Bottin and Tibbetts 2000).

To reduce wave heights at the breakwater and minimize further damage, a submerged reef breakwater had been constructed lake-ward of the original structure during the construction seasons between June 1995 and August 1998. The photogrammetry conducted in 1999 not only quantified changes since 1995 but established new base conditions for the structure upon which the performance of the reef breakwater can be evaluated in future years.

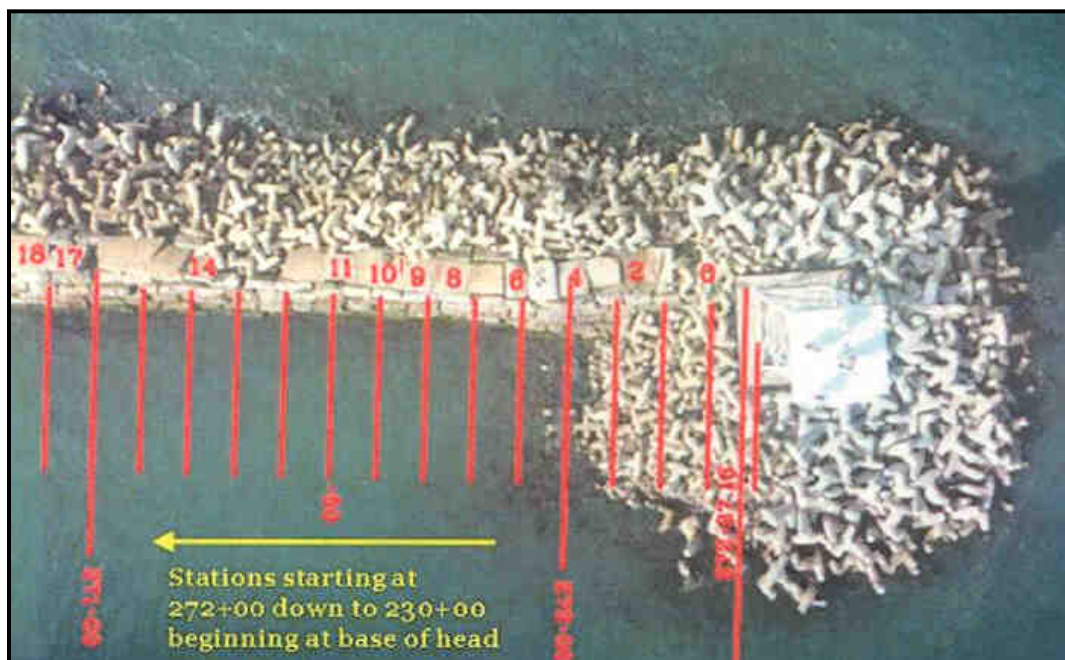
Figure 29 shows an aerial photograph and layout example of station marks on the Cleveland Harbor East Breakwater. Dolos distances from the center line were estimated on 5 ft intervals. A handheld Garmin GPS unit was used to take latitude, longitude, and elevation coordinates for each damaged dolos. This provided approximate location measurements and was used to determine the efficacy of this process for future monitoring as well as to provide a baseline for the Periodic Inspections GIS.

Figure 29. Example of station number layout for Cleveland Harbor East Breakwater.

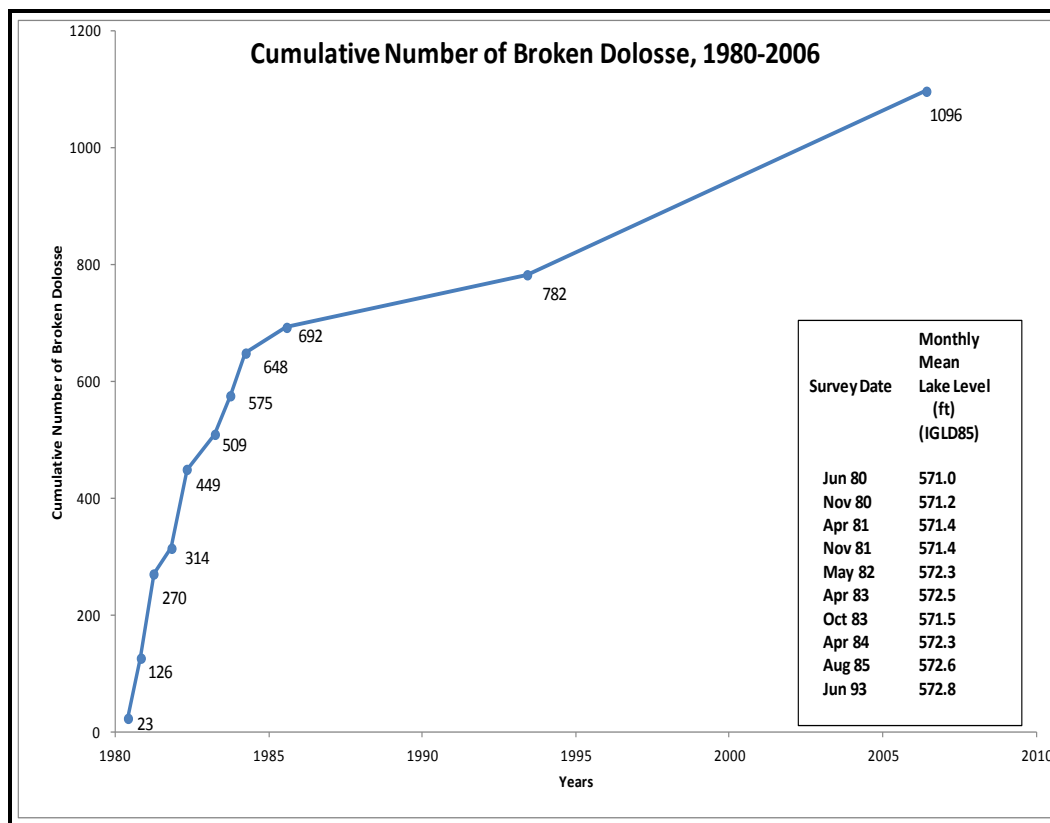
Of the 1,128 damaged dolos units, 171 were found to have multiple breaks/cracks. Thirty-two of the 171 were in pieces. This is significant for comparison purposes because the 1993 monitoring did not count dolosse broken into pieces. The number of comparable multiple breaks for 2006 is 139 versus 48 in 1993, and the overall number of damaged dolosse is 1,096 for the 2006 walking inspection versus 782 in 1993. These data are shown in Figure 30 for the intervening 13 yr between 1993 and 2006.

With 692 broken/cracked dolosse in 1985, 782 in 1993, and 1,096 comparable dolosse in 2006, it appears the rate of breakage has somewhat increased. The 8 yr difference between 1985 and 1993 yielded an average of 11.25 new broken units per year, while the 13 yr difference between 1993 and 2006 showed an average of 24.1 new broken units per year, more than double.

Figure 30. Cumulative number of broken dolos armor units, including July 2006 detailed walking inspection, Cleveland Harbor East Breakwater.

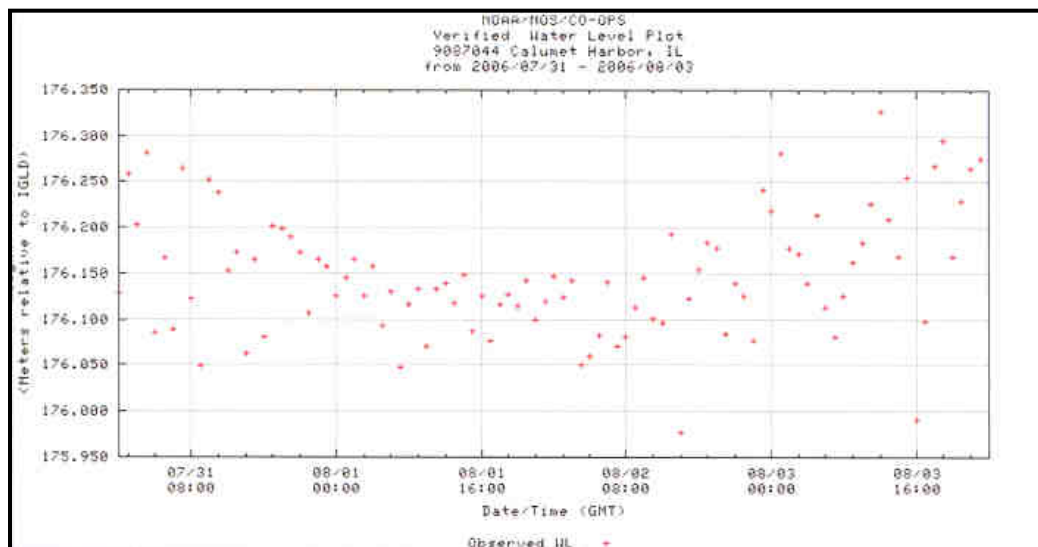
The detailed walking inspection of Burns Harbor North Breakwater revealed 282 broken/cracked armor stones. Water levels during the walking inspection fluctuated very little with extremes of 577.4 to 578.4 ft IGLD85 and with an average of 577.9 ft IGLD85 (Figure 31). Water level data were obtained from NOAA wave gage number 9087044 located offshore of Calumet Harbor, IL, at latitude 41°48.8' N and longitude 87°32.3' W.

Figure 31. Water level (m) time-history from NOAA offshore gauge 9087044, Burns Harbor North Breakwater, August 2006 detailed walking inspection.
